PUBLIC ROADS

VOL. 17, NO. 7

SEPTEMBER 1936

The Structural Design of Concrete Pavements	143
Part 4: A Study of the Structural Action of Several Types of Transverse and Longitudinal Joint Designs.

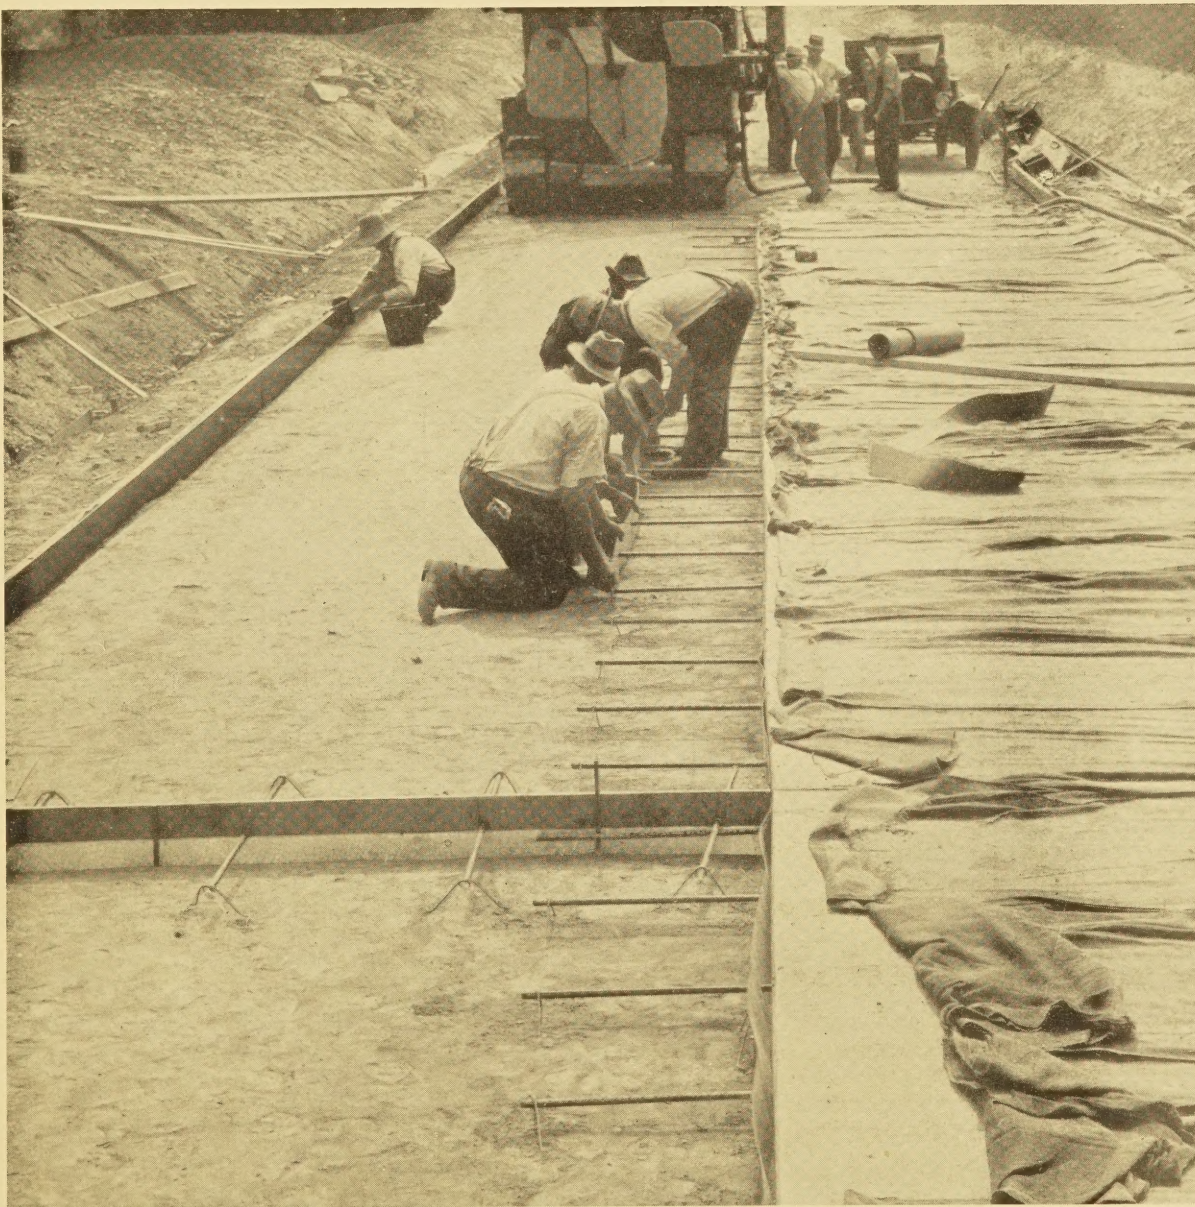
PLACING TARRED FELT ALONG A LONGITUDINAL JOINT

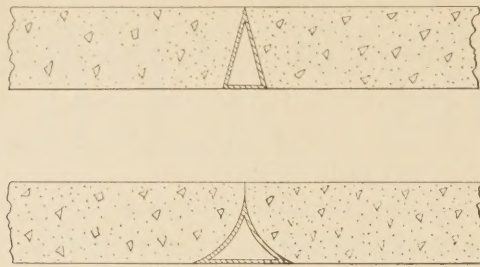
PATENT GRANTED 1885
NO. 312,897—C.F. RAPP

FIGURE 1.—ONE OF THE FIRST JOINT DESIGNS FOR CONCRETE PAVEMENTS PATENTED IN THE UNITED STATES.

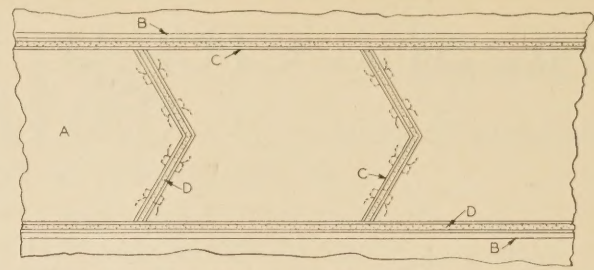
A—CONCRETE PAVING B—CURB C—IRON STRIPS
D—ELASTIC FILLER E—SUPPORTING PLATE

"As it is well known, irregularly running cracks appear after a short time in paving made from concrete or other cement mixtures, which lead to the destruction of the pavement. * * * I avoid this irregular formation of cracks by providing for the occurrence of cracks at definite places and causing them to run in a direction previously determined upon." Mr. Kieserling's design for accomplishing this control of cracking is shown in figure 2.

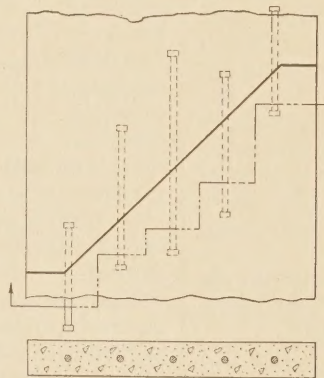
H

PATENT GRANTED 1918
NO. 1,279,431—A. E. POULSTON

Figure 3 shows typical joint designs for which patents were granted in this country during the decade following 1910. The essential feature of the design shown in figure 3-A was the use of steel protection plates at the joint edges, tied in to a general system of reinforcement. The object of the design shown in figure 3-B was to permit the placing of the joint filler in advance of the concreting operation. It will be noted that an air chamber was provided to take care of the filler material during expansion. Figure 3-C shows a design intended to protect the edges of the slabs and at the same time serve as a container for the filler.

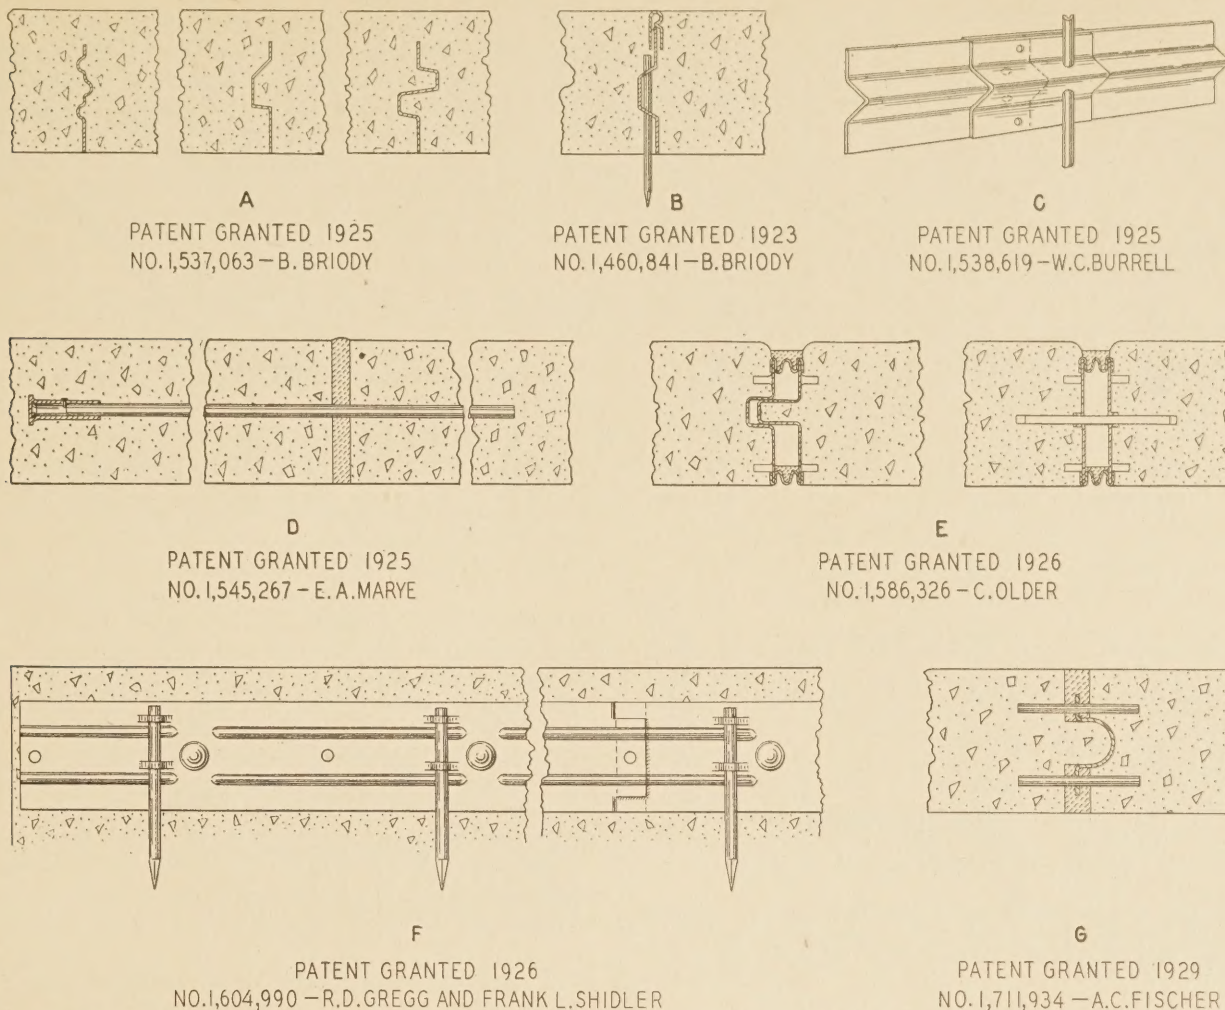
FIGURE 4.—SOME JOINT DESIGNS THAT WERE PATENTED IN THE UNITED STATES BETWEEN 1919 AND 1929.

Figure 4-A shows a method for the control of cracking by means of a transverse, steel parting strip so deformed as to create corrugations of various shapes to provide for an interlocking action of the two slab edges. Figure 4-B is similar except that complete separation is provided without cracking and a single approximately rectangular tongue and groove is formed. Figure 4-C shows a deformed metal plate intended for longitudinal

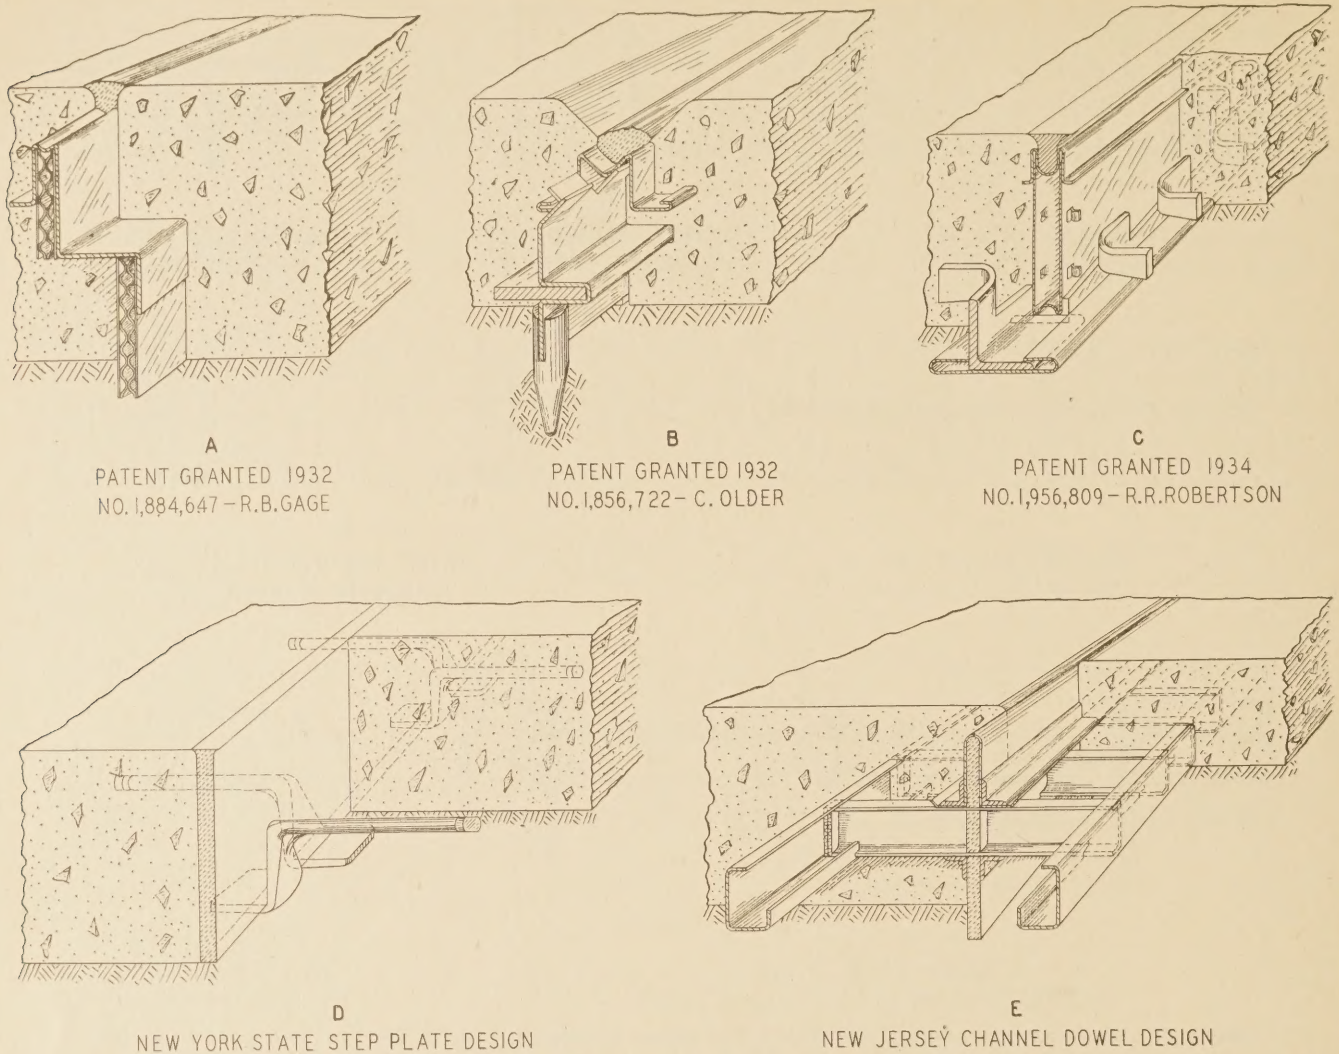
FIGURE 5.—JOINT DESIGNS THAT TYPIFY VARIOUS OPINIONS AS TO WHAT IS REQUIRED STRUCTURALLY IN JOINT ACTION.

An examination of the designs shown in figure 5 will reveal how widely opinions vary as to what is required structurally in joint action. It will be noted that some believe that a joint should be shear resistant

A design differing radically in principle is that used by the State of New Jersey and shown in figure 5-E. The theory behind this design is that the same resistance to bending should be provided at the joint as is found at the other points along the slab, and the series of stiff members which span the joint in this design are for this purpose.

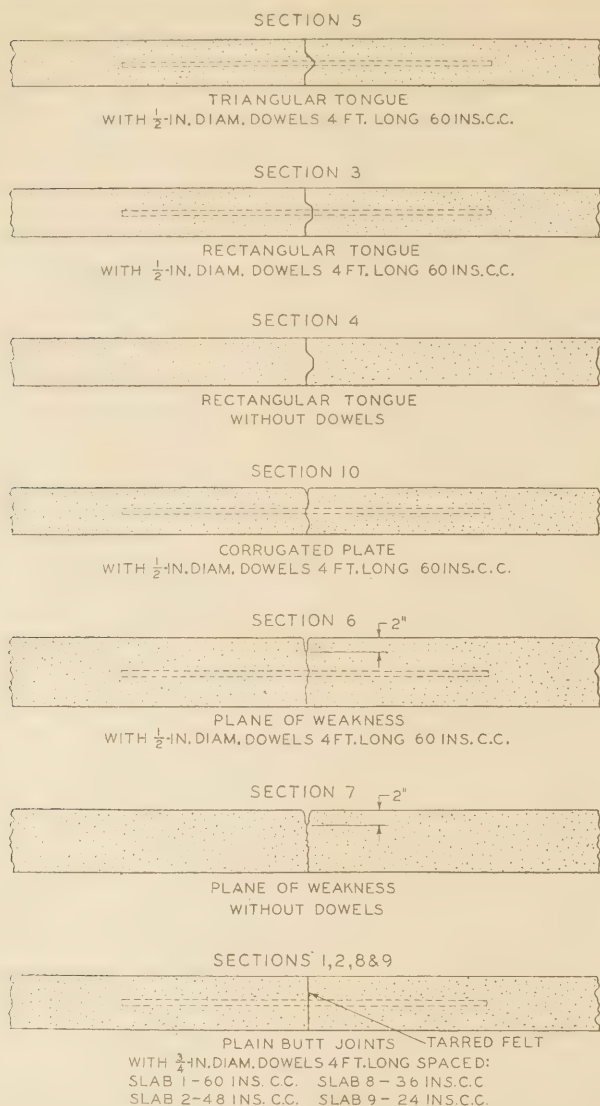
FIGURE 7.—DESIGNS OF LONGITUDINAL JOINTS INCLUDED IN THE INVESTIGATION. ALL DOWELS (OR DEFORMED TIE BARS) WERE BONDED THROUGHOUT THEIR LENGTH.

Details of the designs of the 10 longitudinal joints are shown in figure 7. With the exception of those found in sections 4 and 7, where no steel crosses the joint and free contraction is permitted, all of the designs are primarily warping joints.

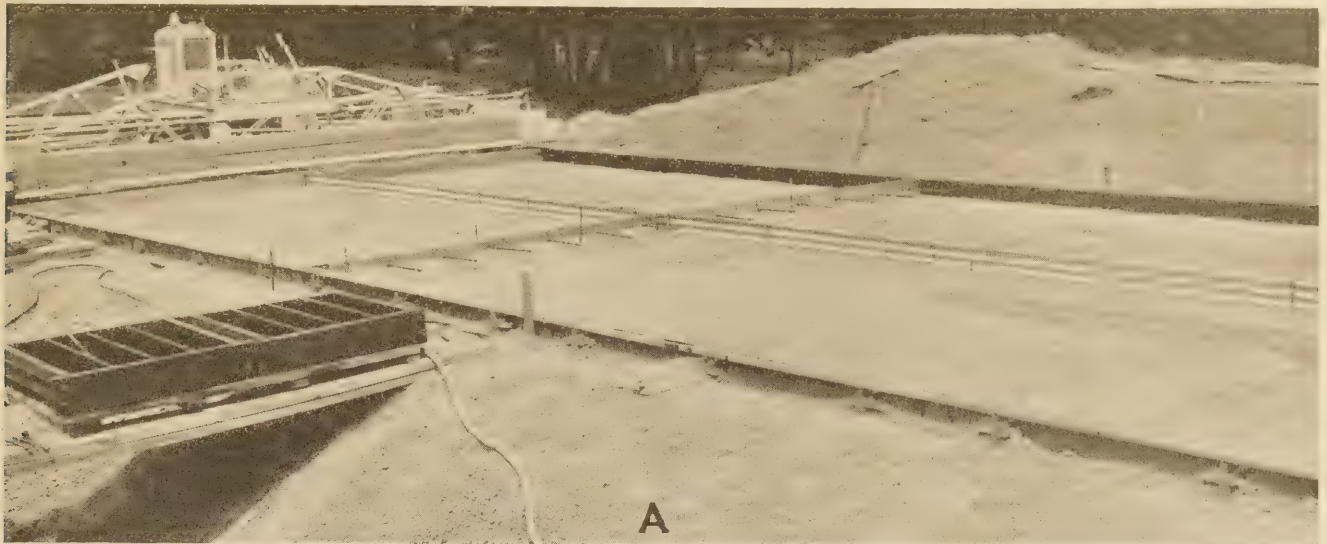
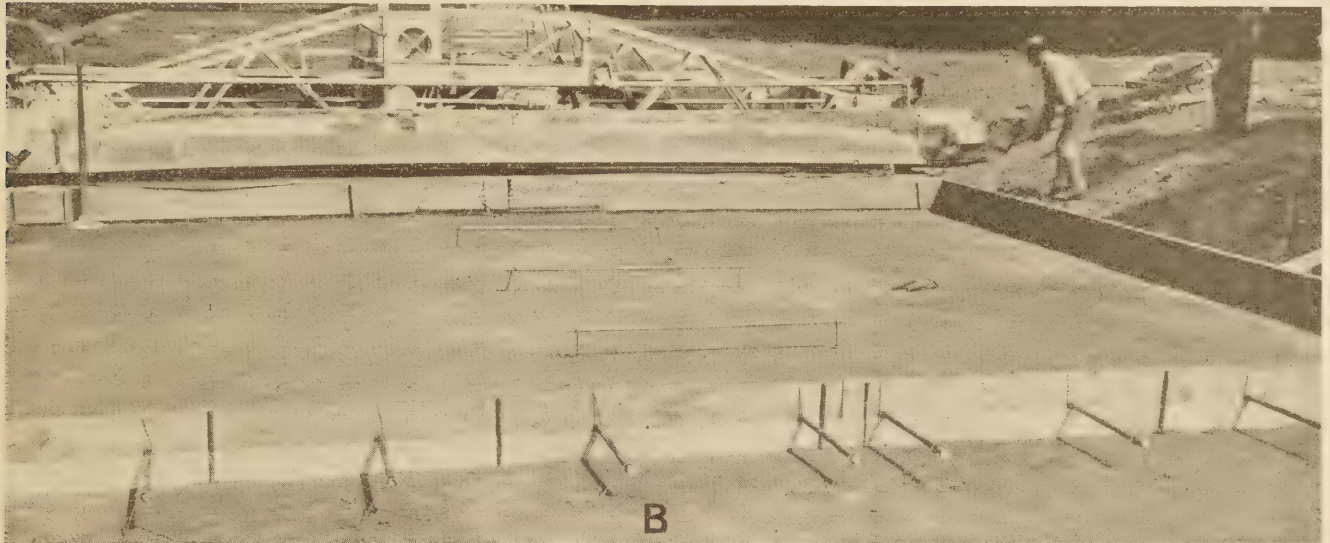
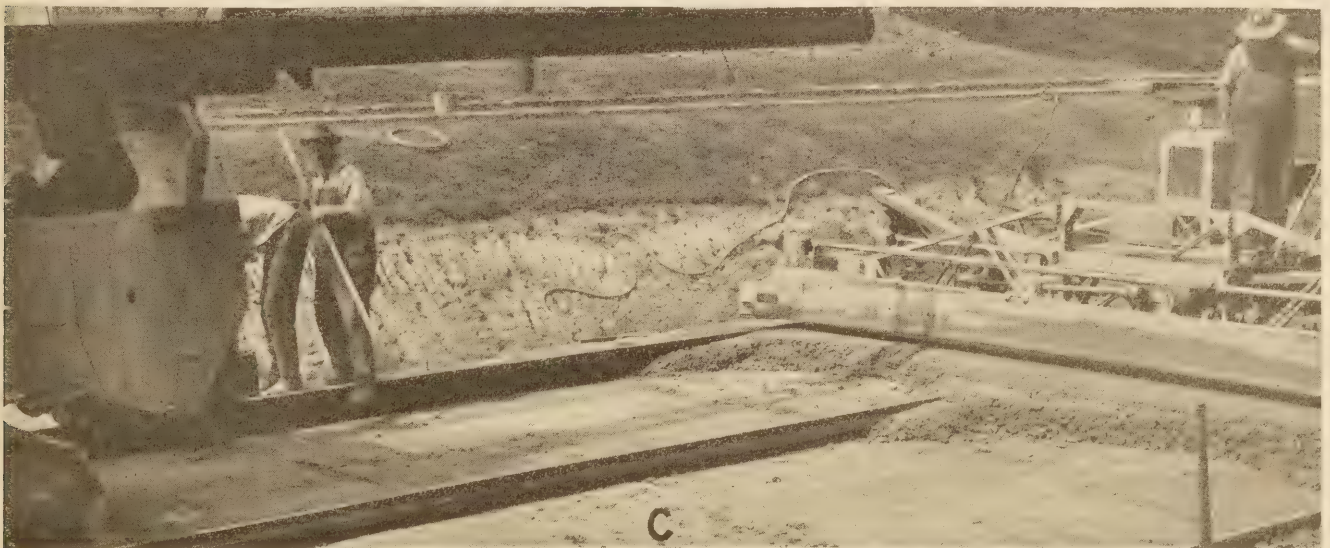
LONGITUDINAL AND TRANSVERSE JOINTS IN PLACE READY FOR THE CONCRETE TO BE CAST. A, CORRUGATED METAL PLATE USED TO FORM THE LONGITUDINAL JOINT IN SECTION 10. B, DOWELS IN PLACE FOR A DOWELED TRANSVERSE JOINT AND FOR A LONGITUDINAL WEAKENED-PLANE JOINT WITH DOWEL BARS IN BOND. THE WOODEN HEADER WAS LEFT IN PLACE UNTIL THE CONCRETE HAD HARDENED AND WAS THEN REMOVED. C, RECTANGULAR TONGUE-AND-GROOVE LONGITUDINAL JOINT.

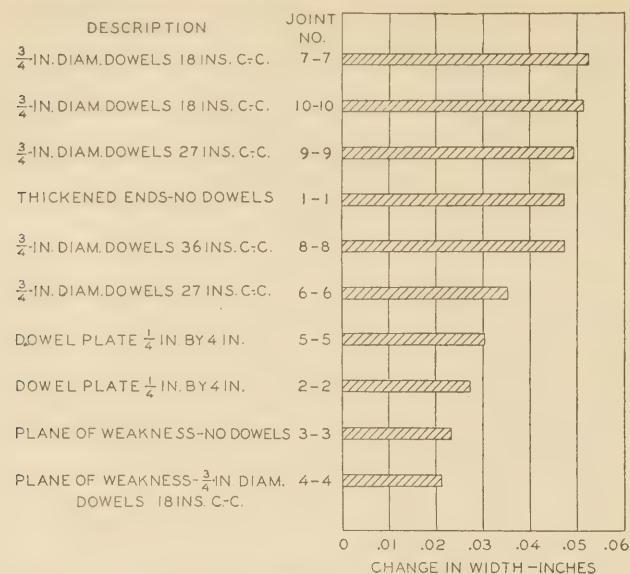
FIGURE 10.—MAXIMUM SEASONAL CHANGES IN WIDTH OF THE TRANSVERSE JOINTS. MAXIMUM RANGE FEBRUARY 16 TO JUNE 22, 1931. THE RANGES SHOWN ARE FROM THE AVERAGE MINIMUM AS SHOWN BY THE MORNING MEASUREMENTS ON COLD DAYS IN FEBRUARY TO THE AVERAGE MAXIMUM AS SHOWN BY THE AFTERNOON MEASUREMENTS ON HOT DAYS IN JUNE.

The restraining forces were calculated in this manner for the four sections in figure 10 that show the least seasonal movement at the transverse joint (secs. 2, 5, 3, and 4), and the estimated unit stress developed by joint restraint in each is shown in table 3 with the data upon which the calculations were based. It is indicated that the dowel-plate joints caused restraint which may develop either tensile or compressive stresses of approximately 30 pounds per square inch, and the plane-of-weakness or dummy joint may cause compressive stresses of approximately the same magnitude. It is probable that if the slabs had been forced to expand and contract against the full resistance of their joints, instead of being comparatively free to shift their position as they were in these tests, a much more serious stress would have resulted.

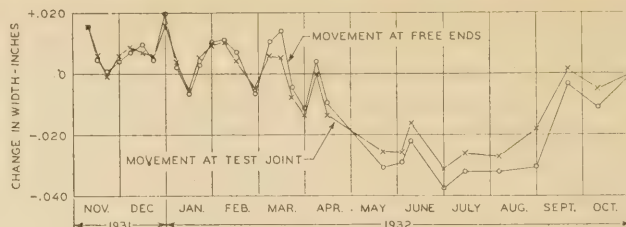
FIGURE 11.—COMPARATIVE MOVEMENTS AT THE TRANSVERSE JOINT AND AT THE FREE ENDS OF ONE OF THE TEST SECTIONS. POSITIVE VALUE INDICATES OPENING OF THE JOINT AND NEGATIVE VALUE INDICATES CLOSING OF THE JOINT.

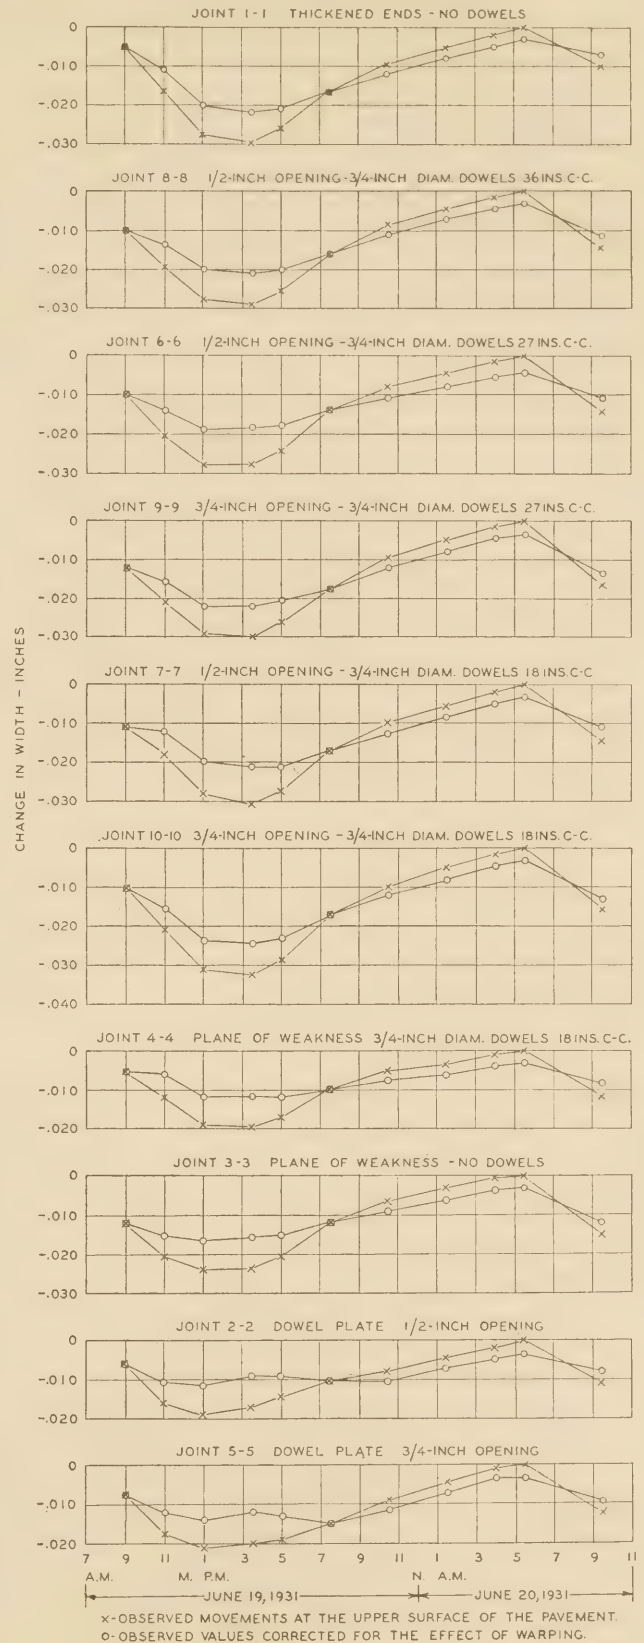
FIGURE 12.—MEASURED CHANGES IN WIDTH OF THE VARIOUS TRANSVERSE JOINTS CAUSED BY DAILY CHANGES IN TEMPERATURE OF THE PAVEMENT. NEGATIVE VALUES INDICATE CLOSING OF THE JOINT.

On the same day that the daily variations in transverse joint width shown in figure 12 were obtained, the warped shapes of the slabs were measured at intervals of approximately 2 hours with the clinometer. From these clinometer data, curves similar in character to those shown in figures 25-28 and 31 of the second paper of this series were obtained. These curves were plotted to suitable scales and the slope of the upper surface at the extreme end of the pavement slab was estimated graphically. From this the change in slope of the vertical end face of the slab was determined for the rather extreme conditions of temperature warping which obtained on the particular day that the measurements were made. From this change in slope the effect upon the measurement of joint width was calculated and applied as a correction to the expansion

and contraction measurements obtained at the transverse joints on the same day. Both the uncorrected and the corrected values are shown in figure 12.

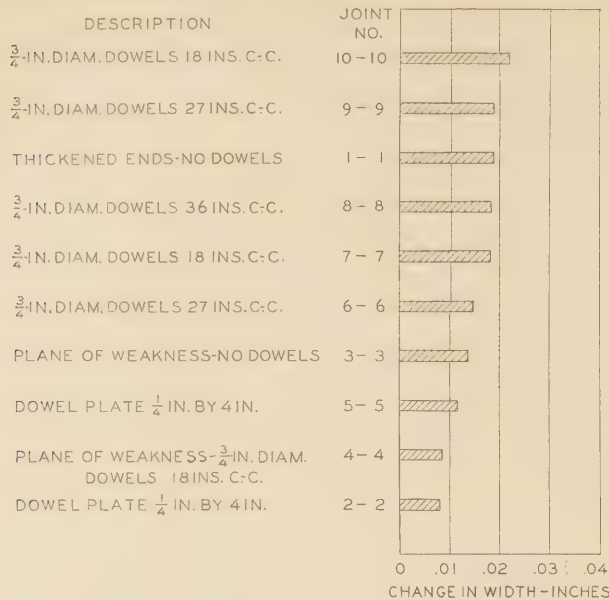
FIGURE 13.—MAXIMUM DAILY CHANGES IN WIDTH OF THE TRANSVERSE JOINTS.

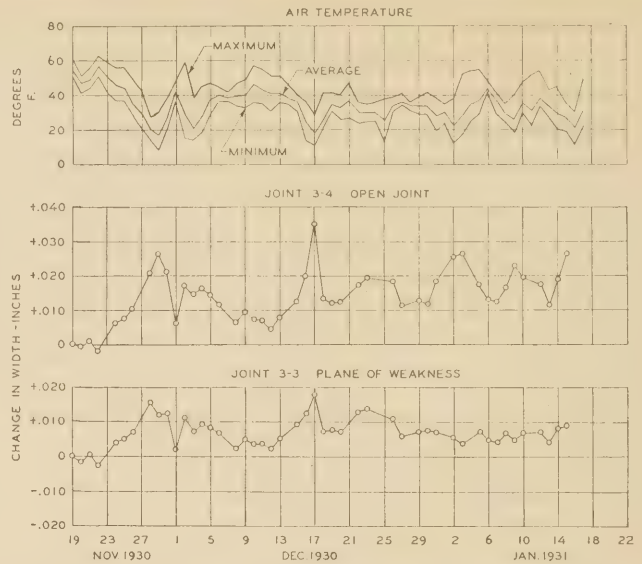
FIGURE 14.—CHANGES IN THE WIDTH OF ADJACENT TRANSVERSE AND OPEN JOINTS DURING A PERIOD WHEN ECCENTRIC MOVEMENTS WERE NOTED. OBSERVATIONS WERE MADE AT 2 P. M. POSITIVE VALUE INDICATES OPENING OF THE JOINT AND NEGATIVE VALUE INDICATES CLOSING OF THE JOINT.

It will be noted in this figure that frequently the movement at the test joint is of about the same magni-

tude as that at the free end, and yet whenever a marked temperature change occurs there is a tendency for the movement at the free end greatly to exceed that at the test joint. This effect is particularly noticeable during a sudden drop in temperature such as that which occurred between December 15 and 17, 1930. Whenever the observed movement at the free end exceeds that at the transverse joint, the slab is not expanding or contracting symmetrically with respect to the midpoint between the two, the slab panel being shifted as a whole toward the end at which the smallest change of position was observed.

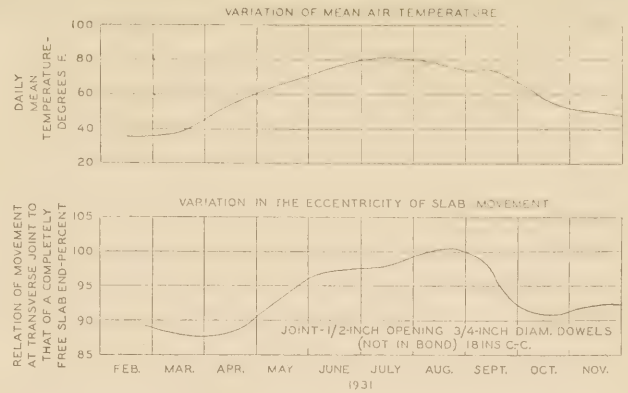
FIGURE 15.—VARIATIONS IN THE ECCENTRICITY OF SLAB MOVEMENT COMPARED WITH THE VARIATIONS OF MEAN AIR TEMPERATURE. THE CURVES SHOW THE GENERAL TRENDS OF THE TEMPERATURE AND OF THE ECCENTRIC MOVEMENTS OF THE JOINTS BUT DO NOT INDICATE CHANGES THAT TAKE PLACE OVER SHORT PERIODS OF TIME.

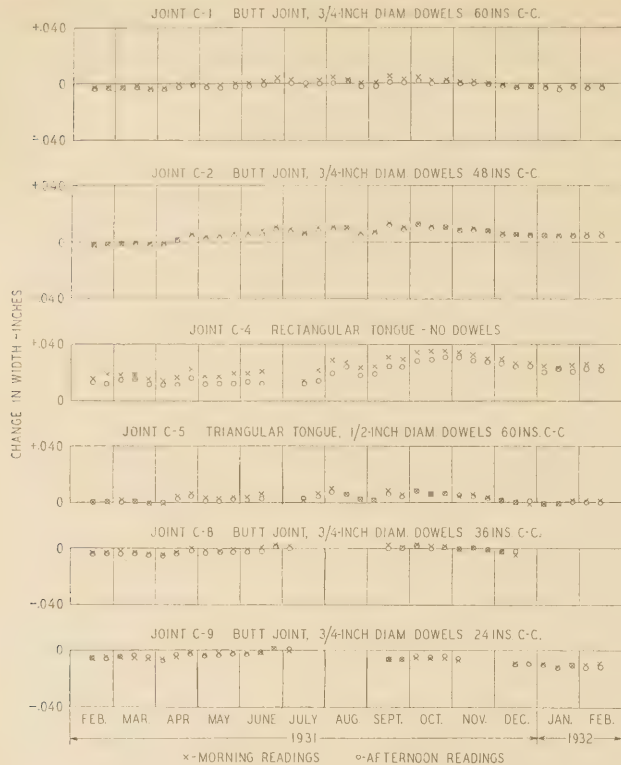
FIGURE 16.—SEASONAL VARIATIONS IN WIDTH OF EACH OF THE LONGITUDINAL JOINTS OVER A TYPICAL 1-YEAR PERIOD. JOINT OPENING SHOWN AS POSITIVE AND JOINT CLOSING SHOWN AS NEGATIVE. EACH VALUE IS A 10-DAY AVERAGE.

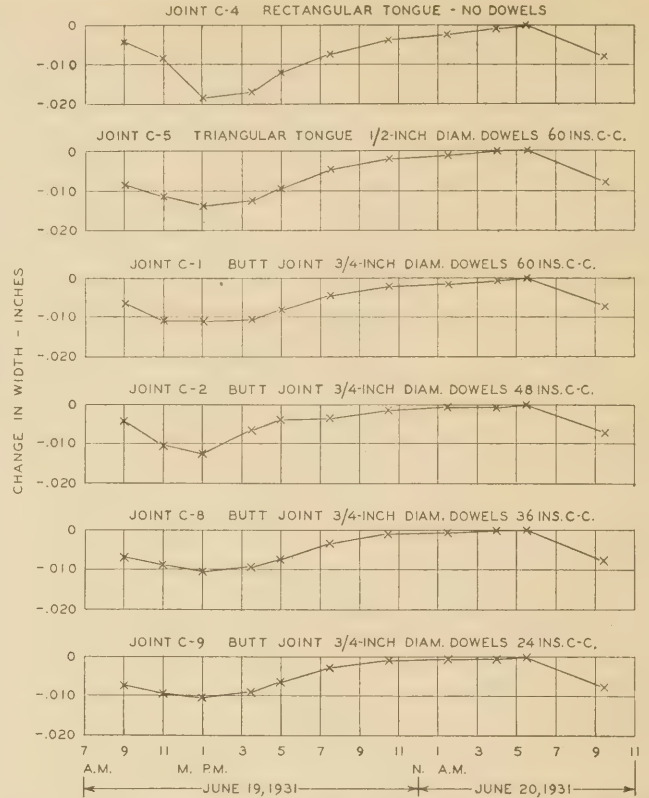
FIGURE 17.—APPARENT CHANGES IN WIDTH OF THE VARIOUS LONGITUDINAL JOINTS CAUSED BY DAILY CHANGES IN TEMPERATURE OF THE PAVEMENT. A NEGATIVE VALUE INDICATES CLOSING OF THE JOINTS.

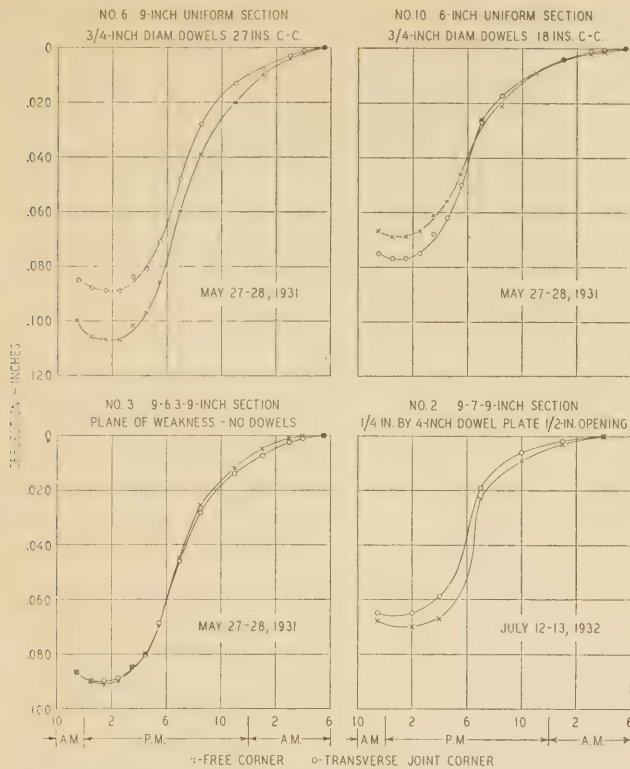
FIGURE 18.—COMPARISON OF THE CYCLES OF TEMPERATURE WARPING MOVEMENTS AT THE TRANSVERSE AND FREE JOINT CORNERS OF TYPICAL SLABS.

Data for two doweled joints, a dummy joint, and a dowel plate are included in this figure. Data for the doweled joint with the dowels at 27-inch intervals indicate some resistance to warping, while those for the other doweled joints in which dowels are installed at 18-inch intervals actually show a greater deflection at the joint corner than at the free corner. This is

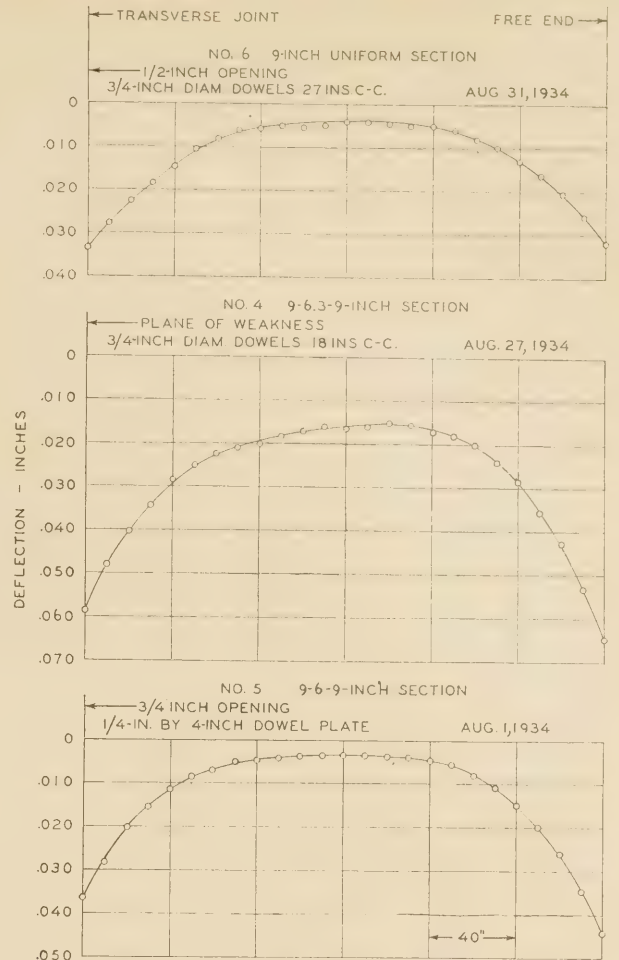
FIGURE 19.—TEMPERATURE WARPING DEFLECTIONS ALONG FREE EDGE OF TYPICAL SECTIONS.

The joint types covered by figure 19 are the same as in the preceding figure, except that the dummy joint shown in figure 19 contains dowels and the dowel-plate joint has a different joint opening. The indications of this graph are in general agreement with those of figure 18 and, so far as these deflection data go, one would conclude that none of the designs of transverse joints included in these observations show any indi-

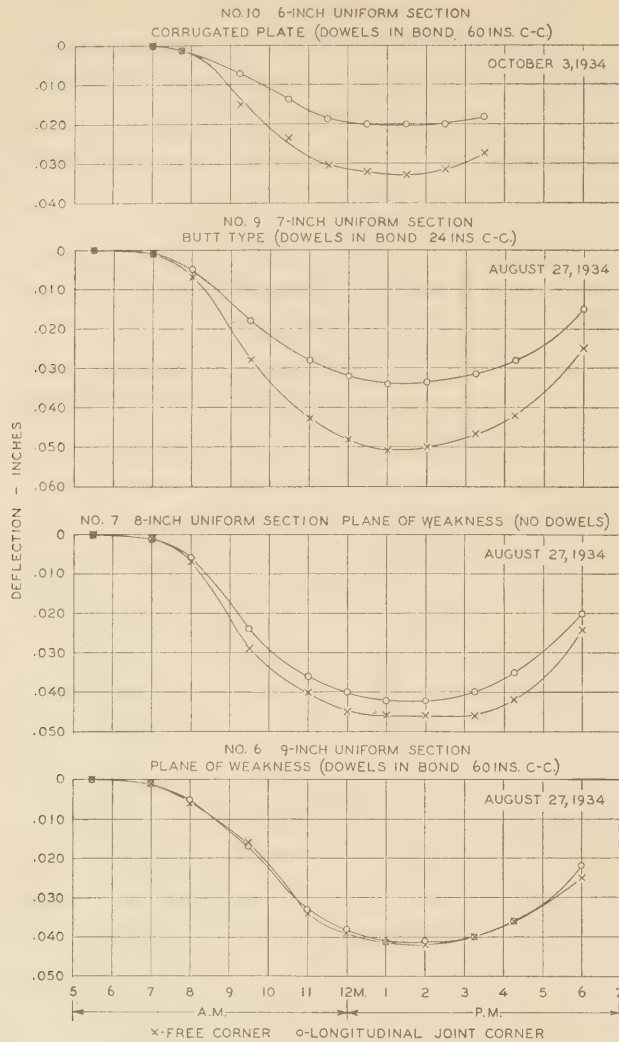
FIGURE 20.—COMPARISON OF THE CYCLES OF TEMPERATURE WARPING MOVEMENTS AT THE LONGITUDINAL AND FREE JOINT CORNERS OF THE SLABS OF UNIFORM THICKNESS.

Figure 20 shows the relative magnitudes of the vertical displacements measured at the free and longitudinal joint corners of each of these four sections

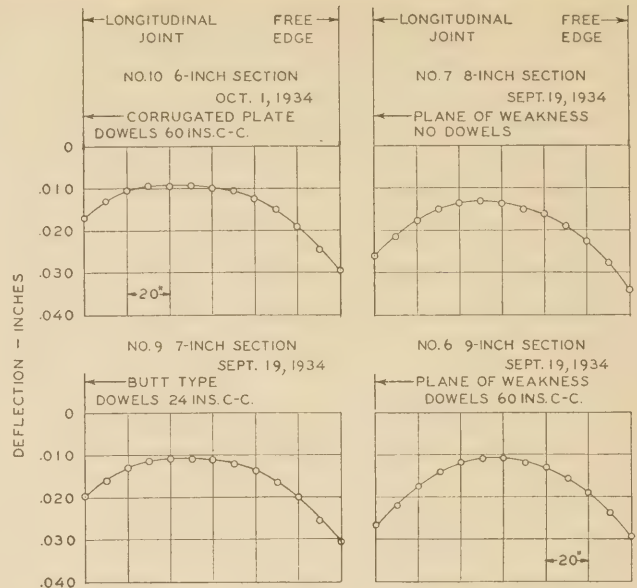
FIGURE 21.—TEMPERATURE WARPING DEFLECTIONS ALONG FREE END OF UNIFORM THICKNESS SECTIONS.

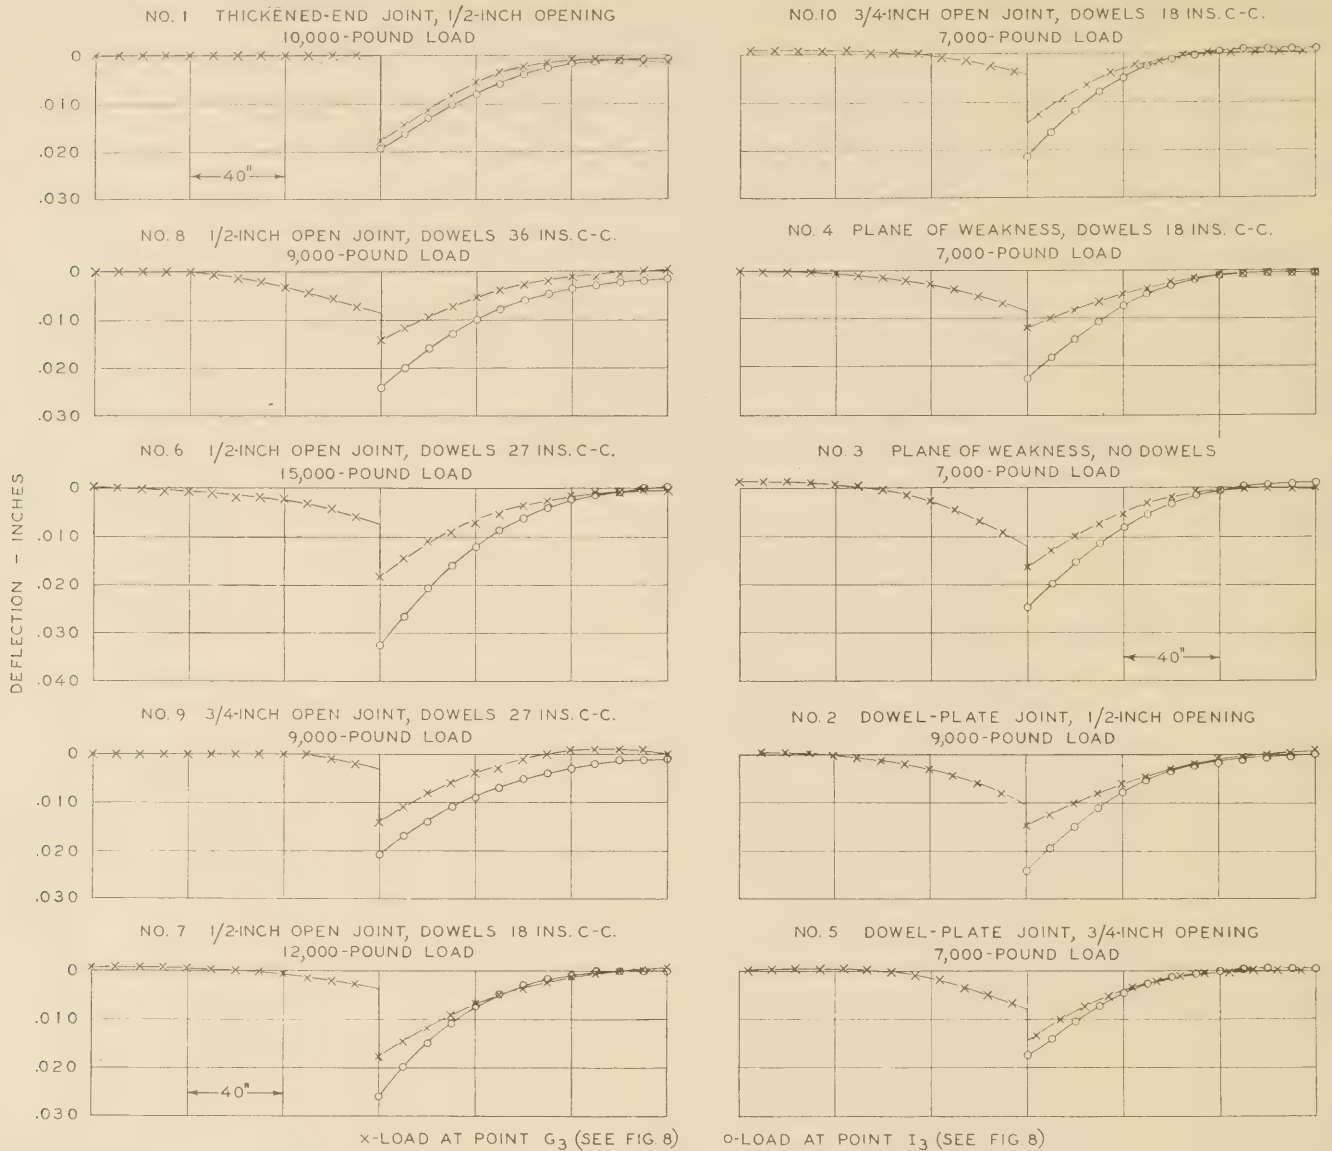
FIGURE 23.—COMPARISON OF DEFLECTIONS ALONG LONGITUDINAL CENTERLINE OF TEST PANELS FOR LOADS PLACED AT MIDPOINT OF FREE END AND AT CORRESPONDING POINT AT TRANSVERSE JOINT. ALL DOWELS USED IN TRANSVERSE JOINTS WERE $\frac{3}{4}$ INCH IN DIAMETER AND 36 INCHES LONG.

Figure 23 shows the extent of the deflections along the centerline of a 10- by 20-foot panel caused by loads applied either at point I_3 or G_3 and indicates the effect of the various transverse joints on the deflection caused by a load acting at a transverse joint at a point away from a longitudinal edge. For a load at point I_3 the shape of the deflected centerline is shown between

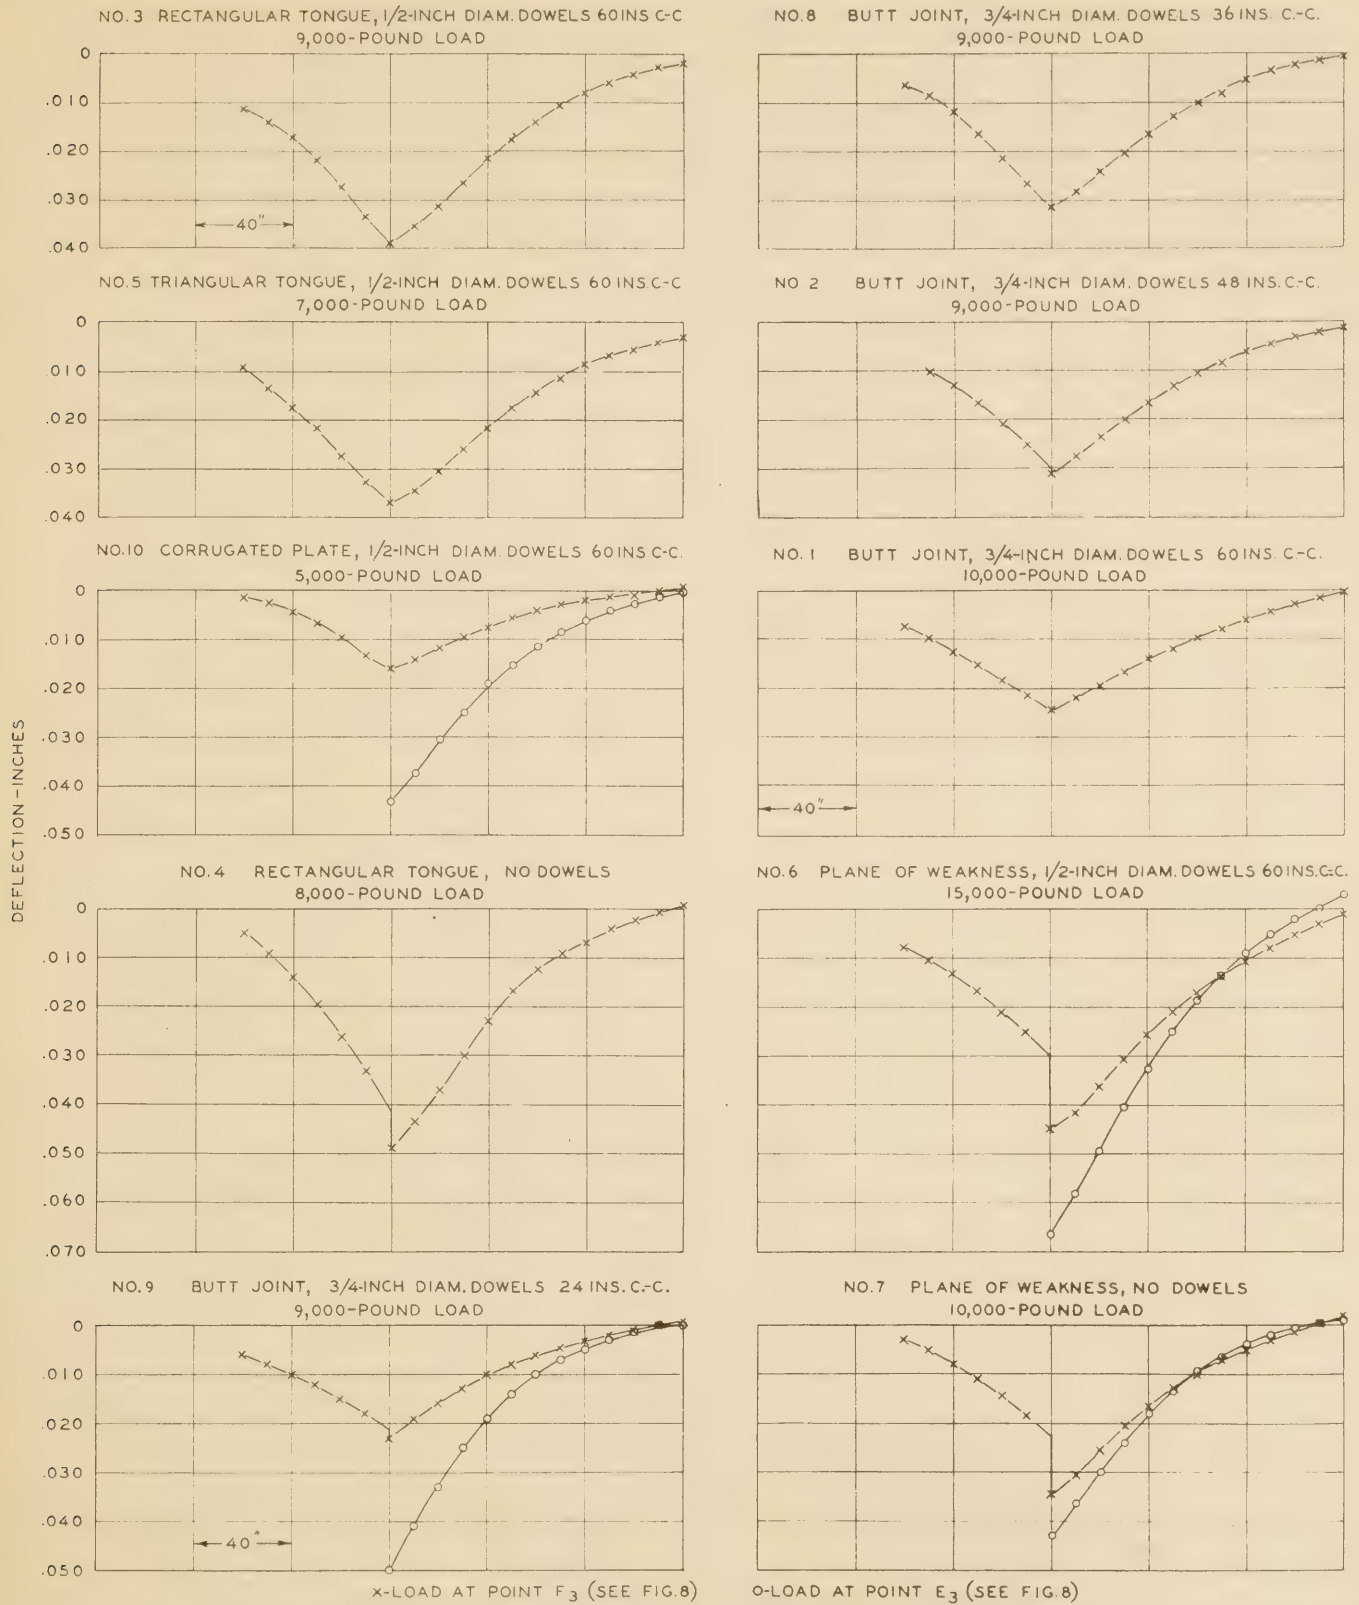
FIGURE 24.—COMPARISON OF DEFLECTIONS ALONG FREE END OF TEST PANELS FOR LOADS PLACED AT FREE CORNER AND AT CORRESPONDING LONGITUDINAL JOINT CORNER. DOWELS 3/4 INCH IN DIAMETER USED IN JOINTS C-1, C-2, C-8, AND C-9; DOWELS 1/2 INCH IN DIAMETER USED IN JOINTS C-3, C-5, C-6, AND C-10. ALL DOWELS IN BOND.

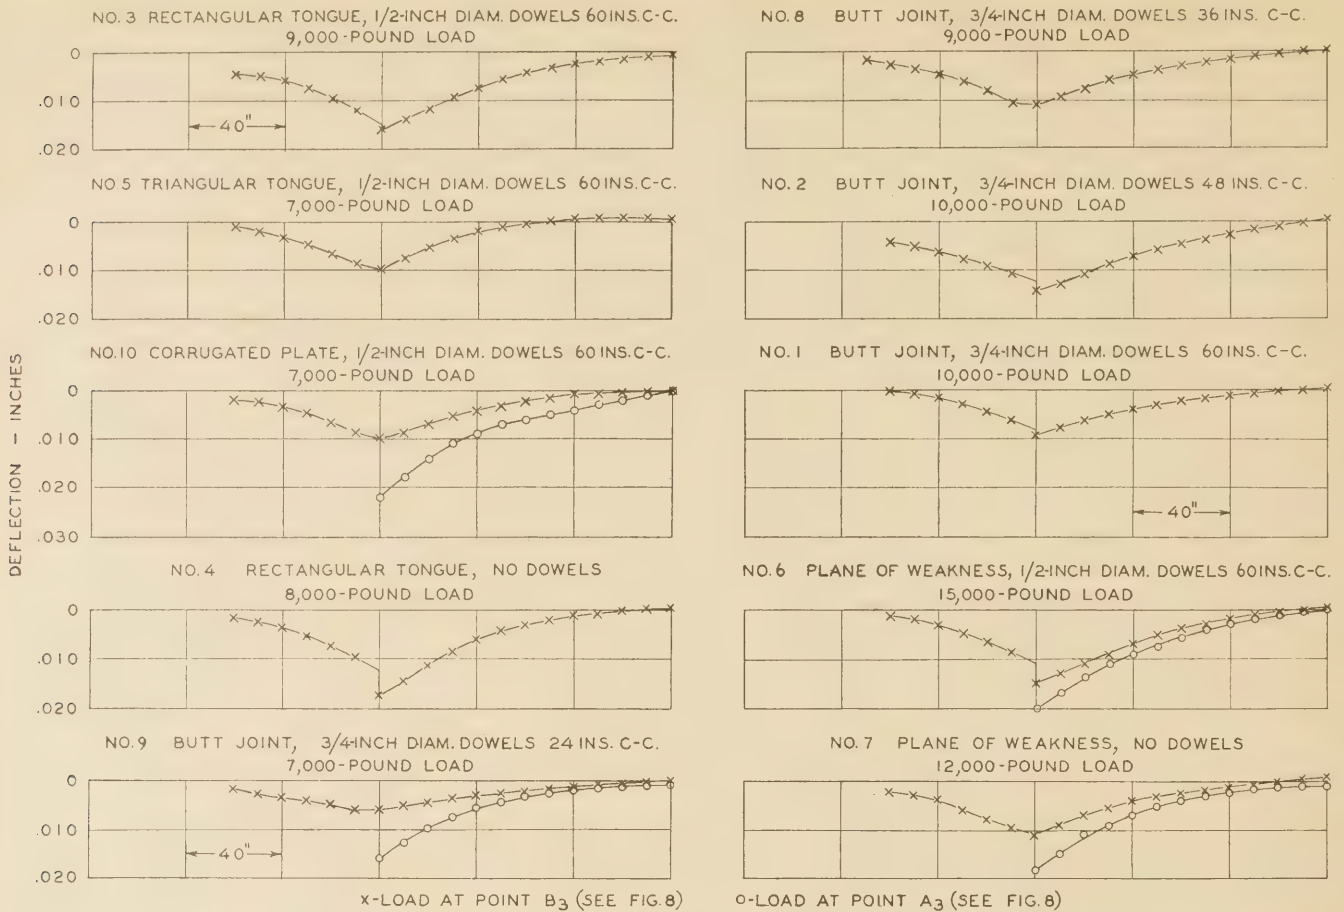
FIGURE 25.—COMPARISON OF DEFLECTIONS ALONG TRANSVERSE CENTERLINE OF TEST PANELS FOR LOADS PLACED AT MIDPOINT OF FREE EDGE AND AT THE CORRESPONDING POINT AT LONGITUDINAL JOINT. DOWELS 3/4 INCH IN DIAMETER USED IN JOINTS C-1, C-2, C-8, AND C-9. DOWELS 1/2 INCH IN DIAMETER USED IN JOINTS C-3, C-5, C-6, AND C-10. ALL DOWELS IN BOND.

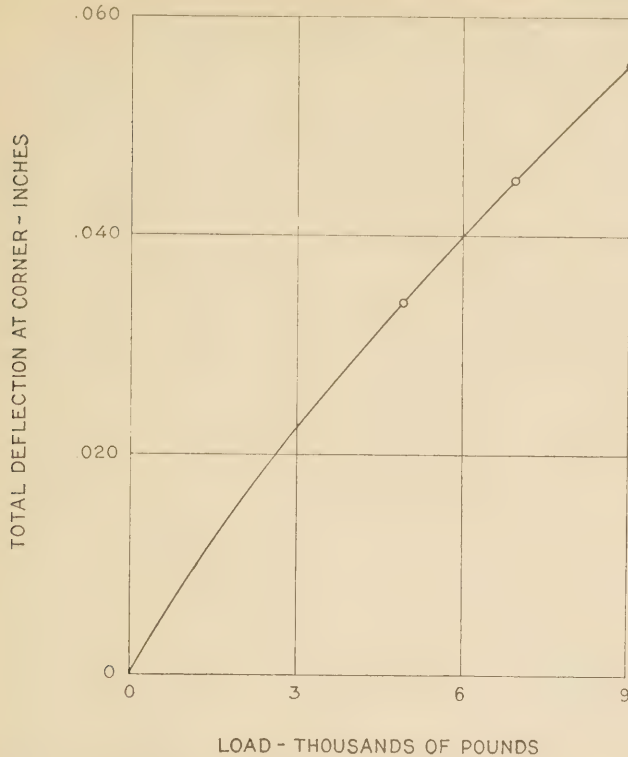
FIGURE 26.—TYPICAL LOAD-DEFLECTION RELATION FOR A LOAD ACTING AT A FREE CORNER.

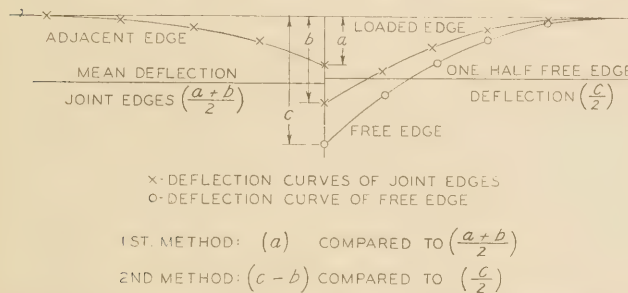
FIGURE 27.—METHODS OF ESTIMATING THE EFFECTIVENESS OF JOINTS FOR REDUCING SLAB DEFLECTION ON THE BASIS OF LOAD-DEFLECTION DATA.

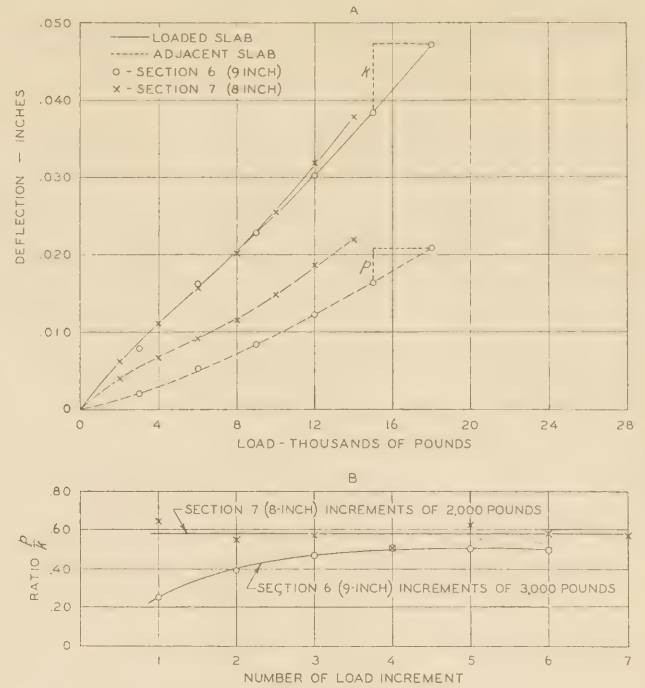
FIGURE 28.—DATA ON STUDY OF DOWEL STIFFNESS AND DOWEL LOOSENESS, TRANSVERSE JOINT CORNERS.

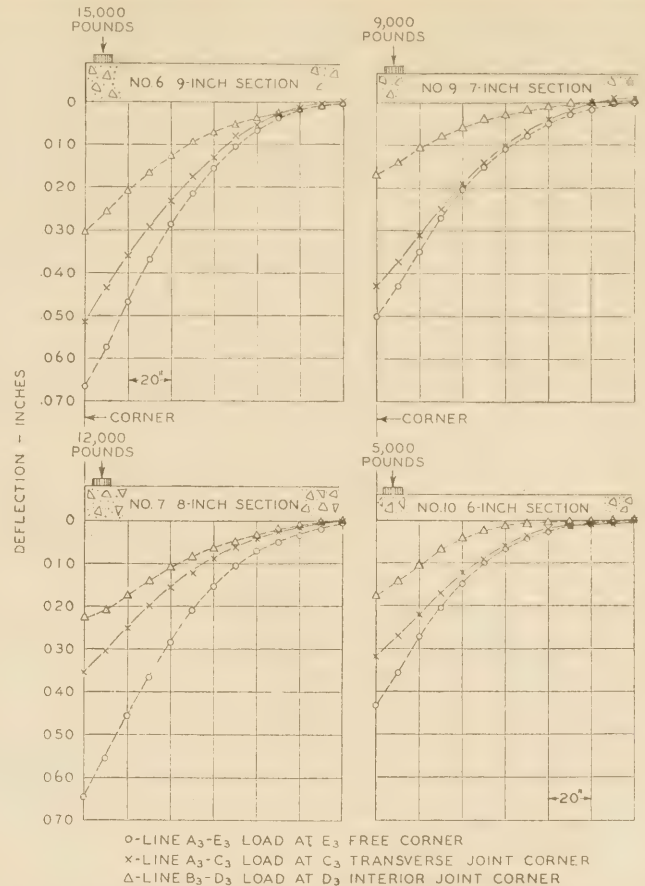
FIGURE 30.—COMPARISON OF DEFLECTIONS OF SLAB EDGES AT THE FREE TRANSVERSE JOINT AND INTERIOR JOINT CORNERS FOR THE UNIFORM-THICKNESS SECTIONS.

As stated earlier, it was possible to make comparisons between the deflections of free and longitudinal joint edges of slabs only for sections of constant thickness and even then only two of the four constant-thickness sections (sections 9 and 10) were suitable for the desired comparison. The other two constant-thickness sections were of the plane-of-weakness type and only one of these contained bonded steel across the joint. It is believed, however, that the relations indicated for sections 9 and 10 will probably be found in any constant-thickness section in which the dummy-joint construction is not used and the slab edges are
